POTASSIUM CORROSION TEST LOOP DEVELOPMENT

Quarterly Progress Report No. 5
For Quarter Ending October 15, 1964

Contract NAS 3-2547

SPACE POWER AND PROPULSION SECTION
MISSILE AND SPACE DIVISION

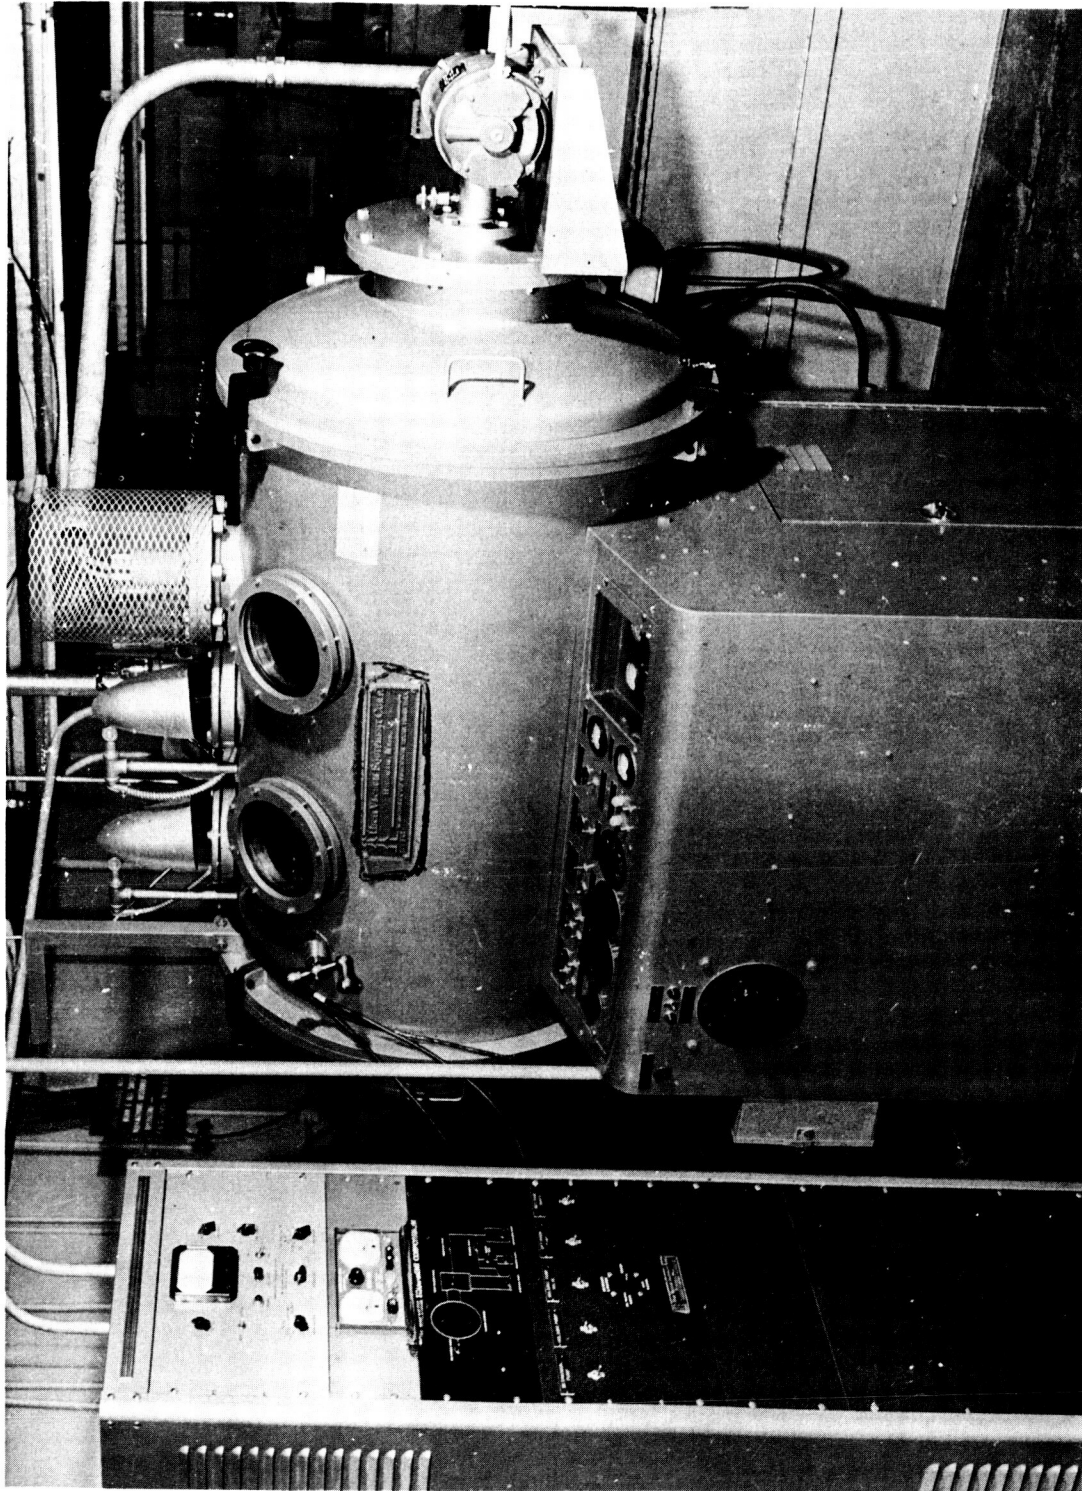
Figure 16. Electron Beam Welding Chamber in Which Refluxing Potassium Capsules were Vacuum Loaded and Sealed by Electron Beam Welding. (C1033002)

The potassium transfer and capsule sealing was accomplished in the electron beam welding chamber, shown in Figure 16. The unit incorporates facilities for transferring potassium directly from the hot trap to the capsules in a vacuum environment of 5×10^{-5} torr. Figure 17 shows an external view of the loading facility with the hot trap in place, and Figure 18 shows the general capsule arrangement inside the chamber. The potassium was transferred to the capsule by pressurizing the hot trap, filling the calibrated stainless steel ladle with the proper amount of potassium and then pouring the potassium through the stainless steel funnel into the capsule using a vacuum rotary feedthrough. After the capsule lid was manually placed on the capsule with the manipulator, the capsule was positioned under the electron beam welding gun at the opposite end of the chamber by means of the motor driven capsule carriage. The lid was then seal welded to the top of the capsule as the capsule was rotated about its own axis. The second capsule was filled in an identical manner.
